Long-term Monitoring of Piled Raft Foundations with Grid-form Deep Mixing Walls on Soft Ground

軟弱地盤における格子状地盤改良を併用したパイルド・ラフト基礎の長期挙動観測

This paper offers two case histories of piled raft foundations supporting two 12-story base-isolated build-ings founded on soft ground in Tokyo. To cope with liquefiable sand and to reduce settlement of thick soft clay layer below the sand, an advanced type of piled raft, a piled raft combined with grid-form deep cement mixing walls, was employed. To confirm the validity of the foundation design, field measurements were performed on the foundation settlements and the load sharing between raft and piles. During the monitoring period, the 2011 off the Pacific coast of Tohoku Earthquake struck the sites. Based on the measurement results for the buildings of two different plan areas, it is confirmed that a piled raft combined with the grid-form deep mixing walls works quite effectively in grounds consisting of liquefiable sand and soft cohesive soil.

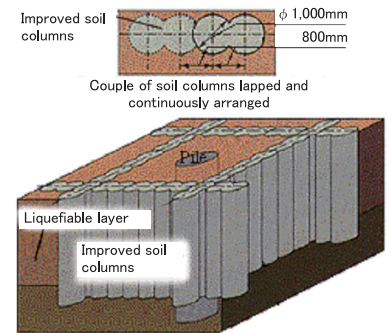
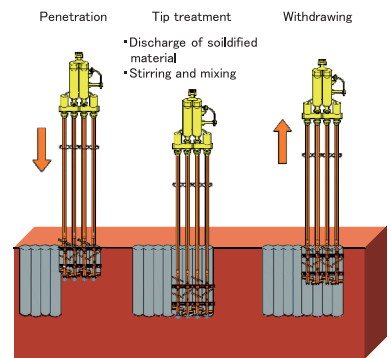
Fig. 1 Grid-form deep cement mixing walls (TOFT)

Figure 1 shows the grid-form deep cement mixing walls constructed by TOFT method. Typical compressive strength of the soil cement is 2 to 3 N/mm² and the high-modulus soil-cement walls confine loose sand so as not to cause excessive shear deformation to the loose sand during earthquakes.

(a) Grid-form deep cement mixing walls

(b) Construction procedure (4-axle type)

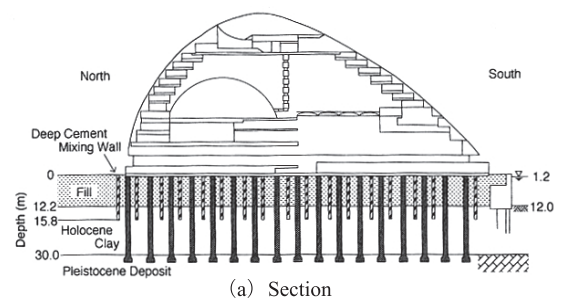
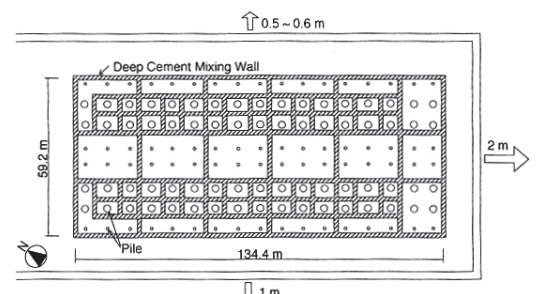
Fig. 2 Building founded on piles surrounded by Deep Cement Mixing wall (Tokimatsu et al., 1996)

The TOFT method was developed late in the 1980s and the effectiveness of the method was confirmed during the 1995 Hyogoken-Nambu earthquake. Figure 2 shows a 14-story building constructed on the pier that faces the Port of Kobe. The building was supported on cast-in-place concrete piles surrounded by the deep cement mixing walls. During the 1995 Hyogoken-Nambu

(a) Section

(b) Foundation Plan

earthquake, the quay walls on the west, south and east of the building moved horizontally by 1 m, 2 m and 0.5 to 0.6 m, respectively. Nevertheless, the building survived without damage to its pile foundations (Tokimatsu et al.¹¹⁾).

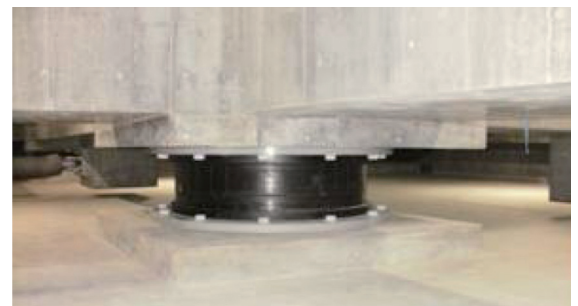
Photo 2 Laminated rubber bearings

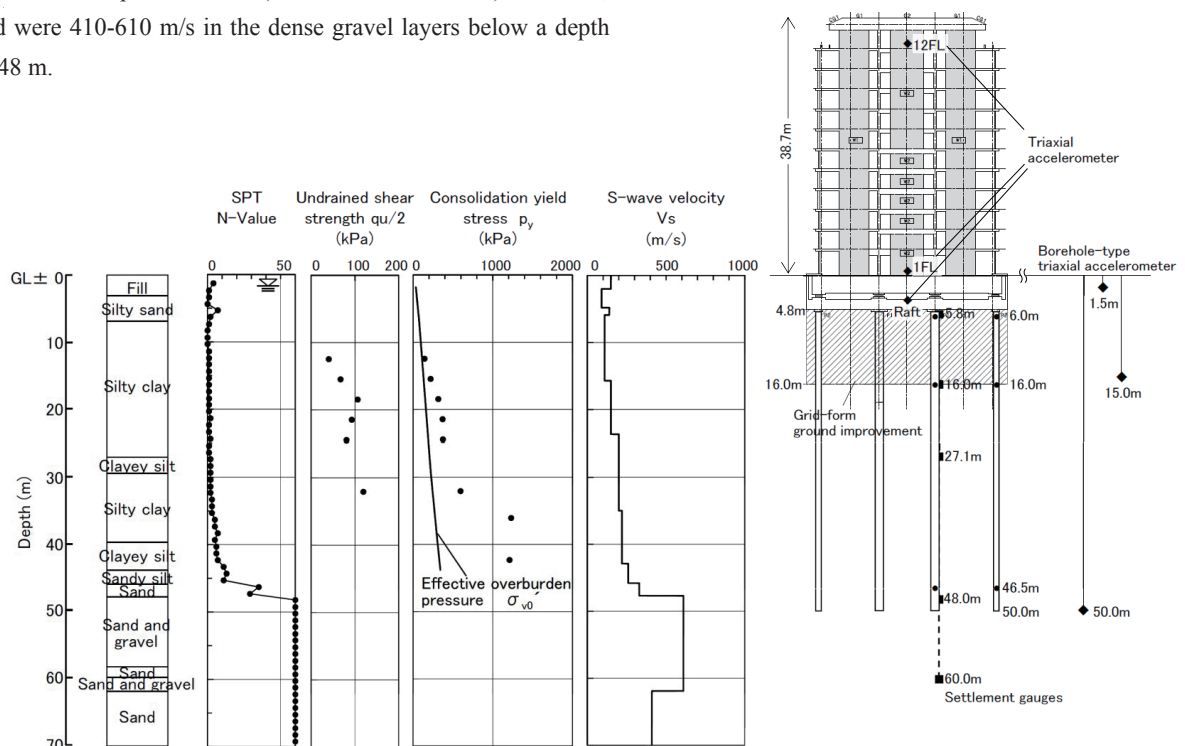
Fig. 3 Schematic view of building and foundation with soil profile

Figure 3 shows a schematic view of the building and the foundation with a typical soil profile. A base isolation system was placed between the raft and the bottom floor of the building (Photo 2). The subsoil consists of an alluvial stratum to a depth of 44 m, underlain by a diluvial sand-and-gravel layer of SPT N -values of 60 or higher. The soil profile down to a depth of 7 m is made of fill, soft silt and loose silty sand. Between the depths of 7 and 44 m, there lie very-soft to medium silty clay strata. The silty clay between the depths of 7 and 15.5 m is slightly overconsolidated with an overconsolidation ratio (OCR) of about 1.5, and the silty clay between the depths of 15.5 to 44 m is overconsolidated with an OCR of 2.0 or higher. The ground water table appears approximately 1.8 m below the ground surface. The shear wave velocities derived from a P-S logging system were 110-220 m/s between the depths of 4.8 m (at the foundation level) and 43 m, and were 410-610 m/s in the dense gravel layers below a depth of 48 m.

The foundation design was based on the design method for piled rafts described in the previous papers (Yamashita et al.¹²⁾, Yamashita et al.⁹⁾). An assessment of the potential for liquefaction during earthquakes was carried out using the simplified method (Tokimatsu and Yoshimi¹³⁾). It indicated that the loose silty sand between depths of 3 and 7 m below the ground surface had the potential for liquefaction with a peak horizontal ground acceleration of 0.2 m/s^2 . Therefore, to cope with the liquefiable sand and to ensure the bearing capacity of the raft, grid-form deep cement mixing walls (the TOFT method), shown in Fig. 3, were employed below the raft.

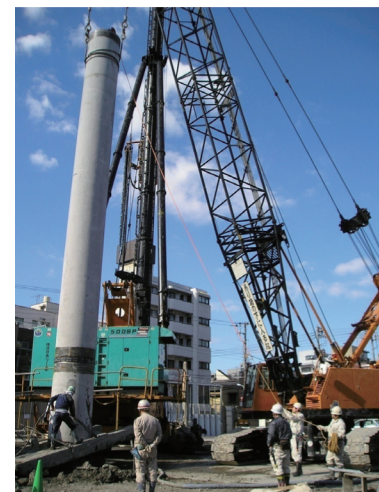
Photo 3 Construction of PHC piles (1.2 m in diameter)

The piles consisted of steel pipe-concrete composite (SC) piles in the top portion and pre-tensioned spun high-strength concrete (PHC) piles in the bottom portion. The piles were constructed by inserting four precast piles (one 12-m-long SC pile and two 12-m-long and one 9-m-long PHC piles) into a pre-augered borehole filled with mixed-in-place soil cement (Photo 3). Figure 4 shows the layout of the piles and the grid-form deep cement mixing walls.

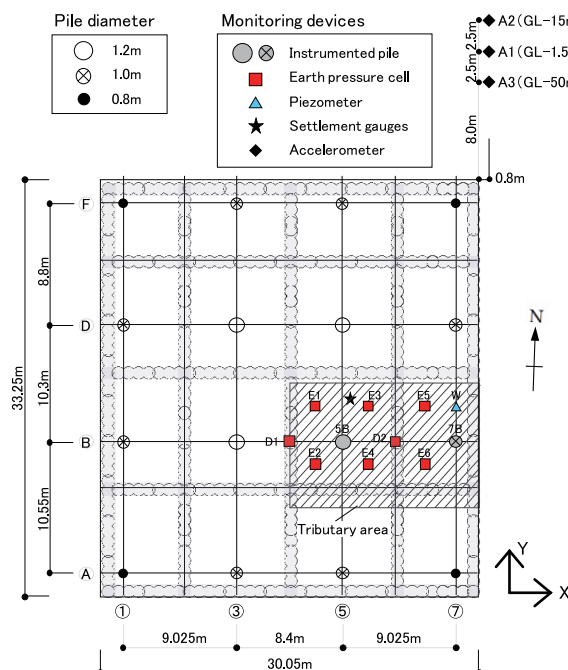
Fig. 4 Layout of piles and grid-form deep cement mixing walls with locations of monitoring devices

Field measurements were performed on the foundation settlement, the axial loads of the piles and the contact pressure between the raft and the soil, as well as the pore-water pressure beneath the raft, from the beginning of the construction to 60 months after the end of the construction. The locations of the monitoring devices are shown in Fig. 4. Two piles, 5B and 7B, were provided with a couple of LVDT-type strain gauges at depths of 6.0 m (pile head), 16.0 m and 46.5 m (pile toe) from the ground surface (Photo 4). Near the instrumented piles, eight earth pressure cells and one piezometer were installed beneath the

raft at a depth of 4.8 m. Six earth pressure cells, E1-E6, were installed on the intact soil, and two earth pressure cells, D1 and D2, were installed on the top surface of the deep mixing walls. The vertical ground displacements below the raft were measured by differential settlement gauges. LVDT-type transducers were installed beneath the raft at depths of 5.8 m, 16.0 m, 27.1 m and 48.0 m to measure the relative displacements to a reference point at a depth of 60 m, as shown in Fig. 3. The settlements of the foundation were measured at the points on the raft by an optical level, where a bench mark was set to the monitoring point of the vertical ground displacements. The measurement of the vertical ground displacements was begun just before the foundation construction excavation, late in November 2007. The measurement of the axial loads on the piles, the contact pressure and the pore-water pressure beneath the raft was begun just before the beginning of the reinforcement of the 1.5-m-thick foundation slab. As for the observations on the seismic response of the soil-foundation-structure system, a vertical array consisting of borehole-type triaxial servo accelerometers was installed at depths of 1.5 m, 15.0 m and 50.0 m below the ground surface to record the NS, EW and UD accelerations of the free-field ground, while triaxial servo accelerometers were installed on the first and the 12th floors as well as the raft to record those of the building, as shown in Fig. 3. The data acquisition system and the devices in the seismic monitoring are shown in Table 2 and Photo 5.

Figure 11 shows the time-dependent load sharing among the piles, the deep mixing walls, the soil and the buoyancy in the tributary area of columns 5B and 7B shown in Fig. 4. The sum of the measured pile-head loads and the raft load in the tributary area after the end of the construction was 35.42-39.83 MN. The raft load means the sum of the total load carried by the deep mixing walls and that by the soil, which was obtained from the measured contact pressures. The sum of the measured pile-head loads and the raft load in the tributary area was found to be consistent with the sum of the design load for columns 5B and 7B (36 MN). Figure 12 shows the ratio of the load carried by the piles to the effective load and that to the total load in the tributary area versus time, where the effective load is the total load minus the buoyancy from the water pressure acting on the base of the

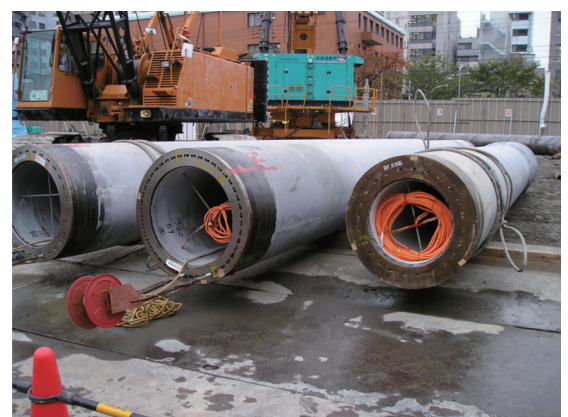
Photo 4 Instrumented PHC piles

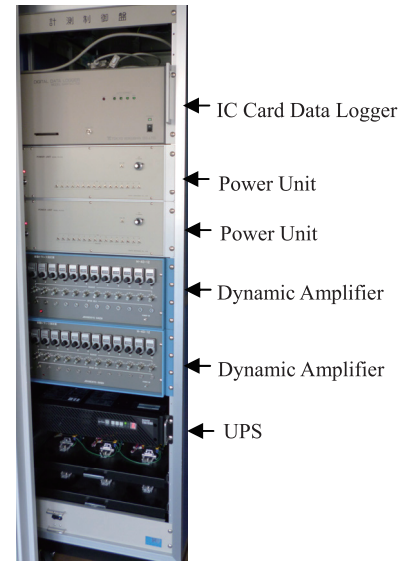
Photo 5 Data acquisition system

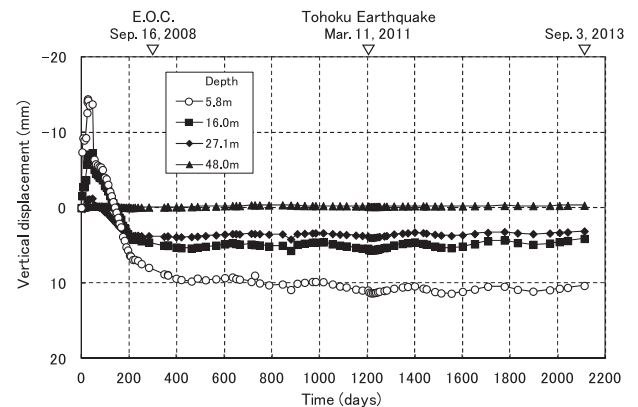
Fig. 5 Measured vertical ground displacements

Figure 5 shows the measured vertical ground displacements below the raft. At a depth of 5.8 m, the maximum ground heaving due to the excavation was 14.3 mm, and then, an immediate settlement of 7.3 mm occurred due to the casting of the 1.5-m-thick foundation slab. Figure 6 shows the measured vertical ground displacements below the raft, at a depth of 5.8 m, initialised a few hours after the casting of the slab. As the immediate settlement was mostly caused by the self-weight of the unset concrete of the raft being directly transferred to the soil, the ground displacement initialised just after the immediate settlement is approximately equal to the settlement of the 'piled raft'. The settlement of the piled raft reached 14.3 mm at the end of the construction (E.O.C.), and thereafter, slightly increased to 17.3 mm, March 10, 2011, just before the 2011 off the Pacific coast of Tohoku Earthquake. Figure 7 shows the settlement profiles of the raft measured by an optical level 22 months after the end of the construction. The maximum angular rotation of the raft was 1/1580 rad.

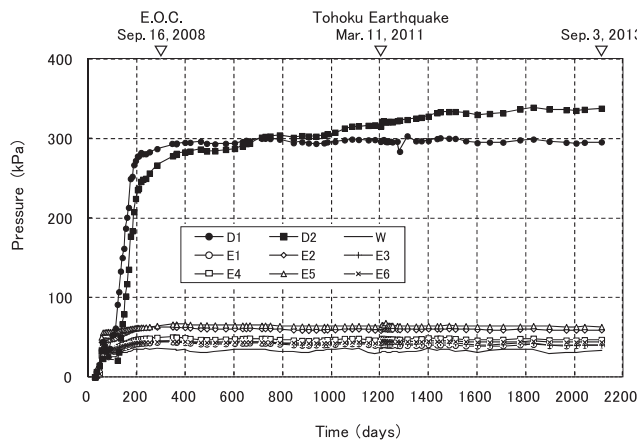
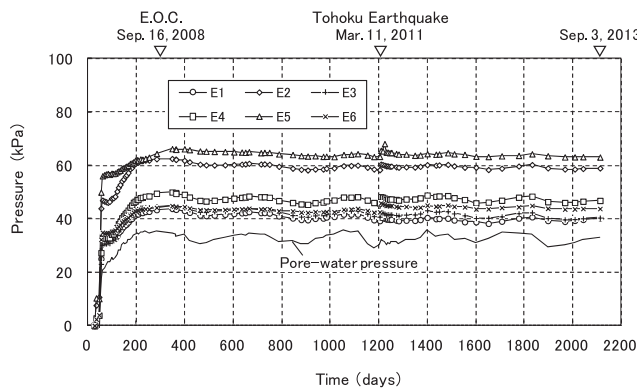
Fig. 10 Measured contact pressure and pore-water pressure

Figure 10 shows the development of the measured contact pressure between the raft and the soil together with the pore-water pressure beneath the raft. On March 10, 2011, the measured contact pressure between the raft and the deep mixing walls reached 296-316 kPa, whereas the pressure between the raft and the soil was 38.8-63.4 kPa. The pore-water pressure was around 30 kPa.

(a) Contact pressure between raft and deep mixing walls and between raft and soil

(b) Contact pressure between raft and soil

The foundation settlement increased by 0.3 mm from the pre-earthquake value, the value measured on March 10, 2011, to 17.6 mm on March 15, 2011, as shown in Fig. 6. Thereafter, the foundation settlements varied from 16.2 to 17.8 mm and were found to be stable. The axial load at the pile head of pile 7B decreased very slightly from the pre-earthquake value of 8.29 MN to 8.15 MN on March 15, while that on pile 5B changed little, as shown in Fig. 8. Thereafter, the axial load varied from 14.19 to 15.31 MN on pile 5B and from 8.02 to 8.34 MN on pile 7B. The contact pressure between the raft and the soil increased from the pre-earthquake values (39.3-63.3 kPa) to 40.6-65.6 kPa on March 15, as shown in Fig. 10. Thereafter, the pressure varied from 38.8 to 64.9 kPa. The contact pressure between the raft and the deep mixing walls near the periphery (D2) increased slightly from the pre-earthquake value of 316 to 321 kPa and that in the inner part (D1) increased very slightly from 296 to 298 kPa on March 15, as shown in Fig. 10. Thereafter, the contact pressure near the periphery (D2) increased slightly, whereas that in the inner part (D1) changed little. The pore-water pressure

increased from the pre-earthquake value of 30.1 kPa to 32.4 kPa on March 15. Thereafter, the pore-water pressure varied from 30.2 to 35.6 kPa due to the effect of seasonal groundwater variations. It is likely that the variations in foundation settlement and axial load of the piles, before and after the earthquake, are closely related with the seasonal groundwater variations.

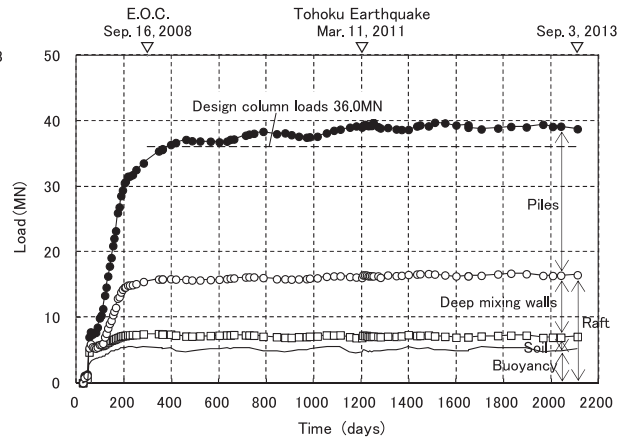
Fig. 11 Time-dependent load sharing among piles, deep mixing walls and soil in tributary area

raft. Table 3 shows the load sharing among the piles, the deep mixing walls and the soil after the end of the construction. The ratio of the load carried by the piles to the effective load increased slightly after the end of the construction and reached 0.669 on March 10, 2011. At that time, the ratio of the effective load carried by the deep mixing walls to the effective load was estimated to be 0.264, whereas the ratio of the effective load carried by the soil was 0.067. The ratio of the load carried by the piles to the total load was 0.589 on March 10, 2011.

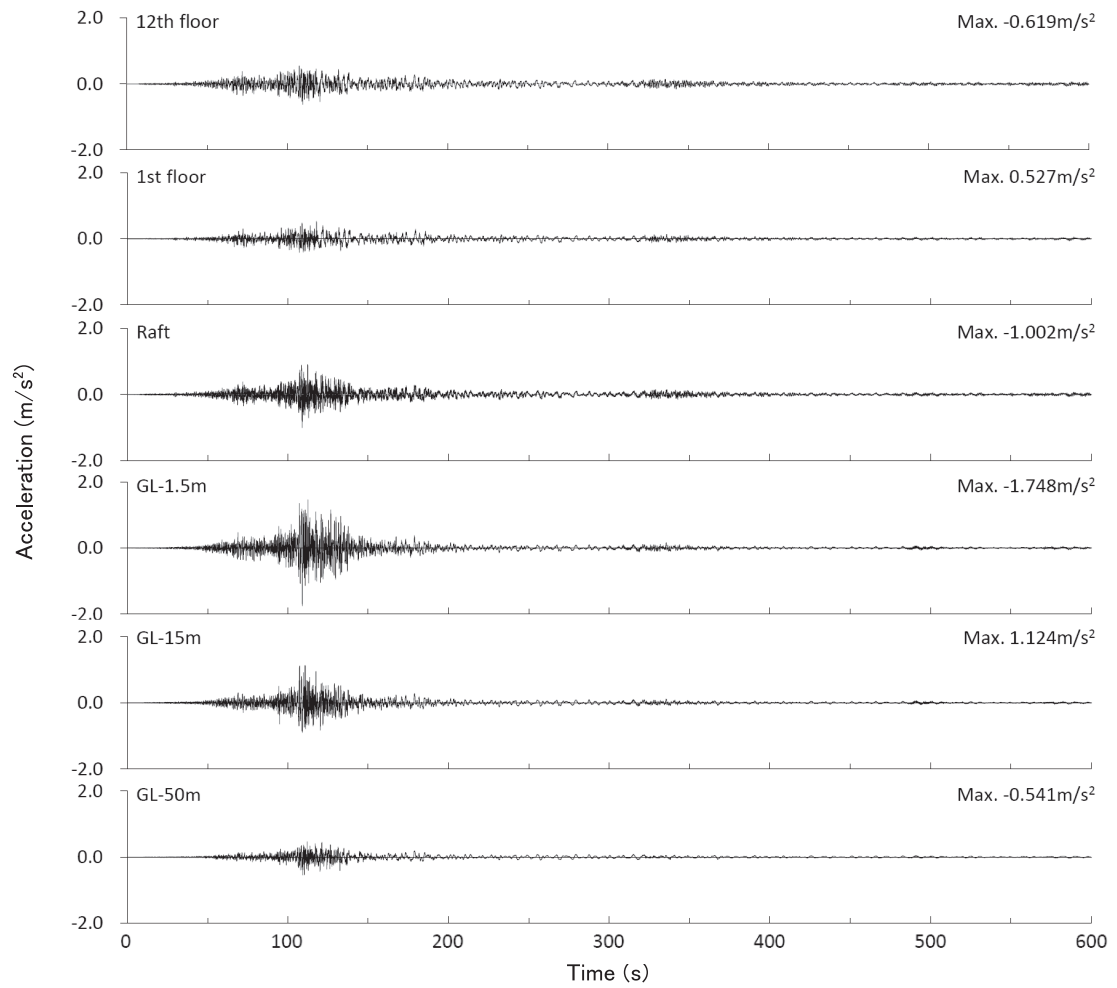
Fig. 13 Time histories of EW accelerations of ground and structure

The seismic response of the soil-foundation-structure system was successfully recorded at the site of the building (Yamashita et al.¹⁴⁾). Figure 13 shows the time histories of the EW accelerations of the ground and the structure. A peak horizontal ground acceleration of 1.748 m/s^2 was observed near the ground surface.

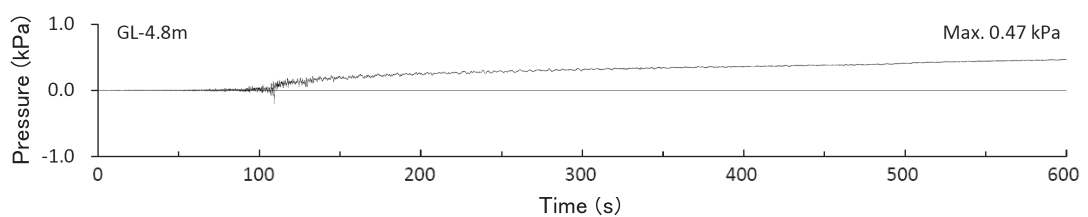
Fig. 15 Excess pore-water pressure beneath raft

Figure 15 shows the pore-water pressure induced by the earthquake in the silty sand beneath the raft. The pore-water pressure increased monotonically to 0.47 kPa 600 s after the start of the event. There was very little excess pore-water pressure and no liquefaction occurred in the silty sand beneath the raft. In addition, no evidence of liquefaction was observed at the site of the building.

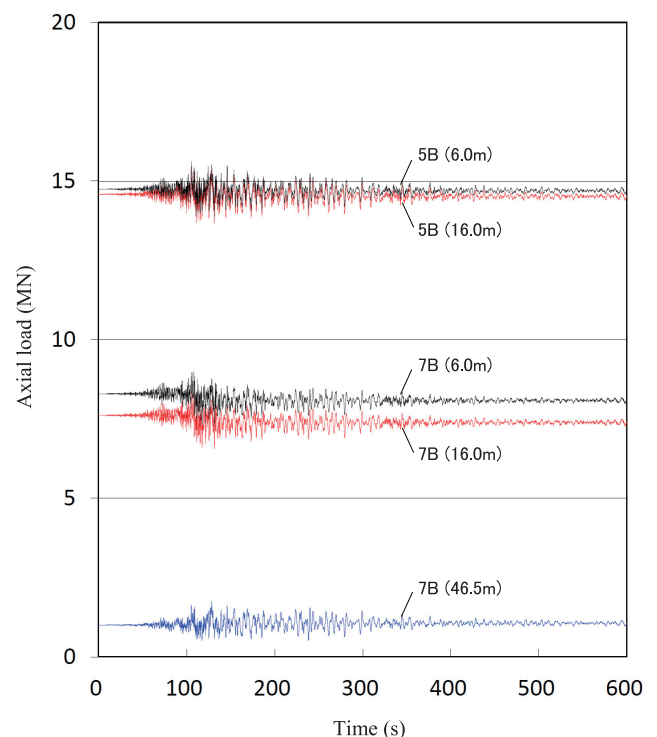
Fig. 17 Time histories of axial loads of piles

Figure 17 shows the time histories of the axial loads of the piles. It can be seen that the axial loads for piles at all depths were in compression during the earthquake. The maximum amplitude for pile 5B at the pile head was 860 kN in compression and 853 kN in tension, while that for pile 7B at the pile head was 694 kN in compression and 1030 kN in tension. The largest amplitudes of axial load occurred at intermediate depths for both piles. Furthermore, the ratio of the load amplitude at the pile toe to that at the pile head was 1.07 in compression and 0.48 in tension, which is considerably larger than the ratio of the pile-toe load to the pile-head load in the static measurements. The increments in axial loads were relatively small because the superstructure was moving primarily in a sway mode by the base-isolation system. The ratio of the maximum amplitude to the axial load at the pile head on March 10, 2011 was 5.8% for pile 5B in the inner part of the raft and 12.4% for pile 7B near the periphery.

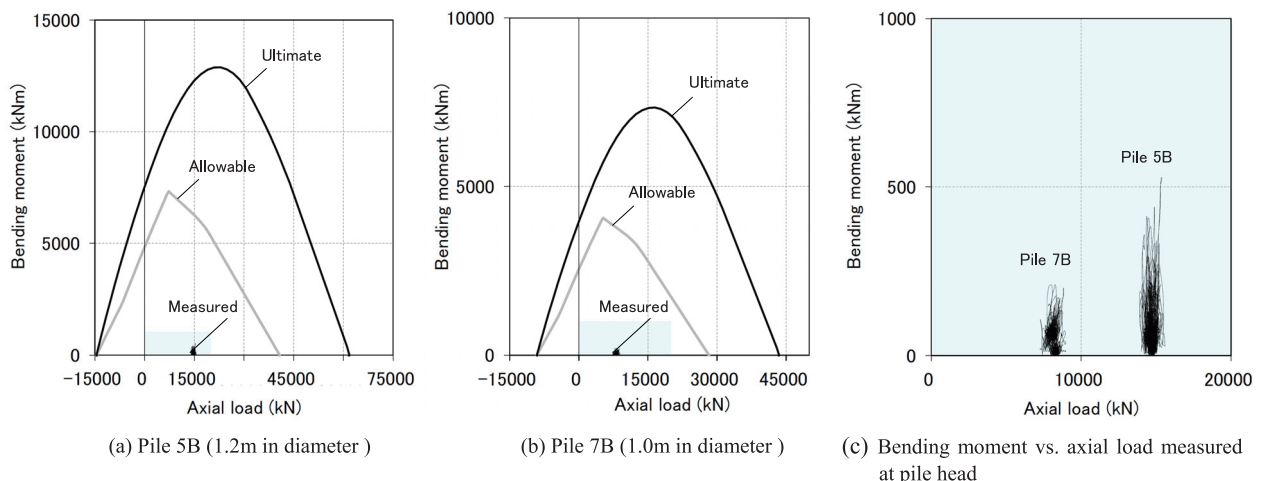
Fig. 18 Interaction curves for axial load and bending moment of SC pile

Figure 18 shows the interaction curves of the axial load and the bending moment of the SC pile corresponding to the allowable and the ultimate bending moments for an axial force in design. Figure 18 also shows the relationship between the axial loads and the bending moments measured for piles 5B and 7B at the pile head during the earthquake, where the bending moments are obtained by combining the components in NS and EW directions. Here, the allowable interaction curve is defined when the unit stress at the edge of the steel pipe reaches the yield stress of 325 N/mm^2 in tension and/or that of the concrete reaches 60 N/mm^2 in compression. The ultimate interaction curve is defined when the unit stress at the edge of the concrete reaches the compressive strength of 105 N/mm^2 and the compressive strain at the edge reaches 5000 micro strain. It is found that the observed bending moments for both piles are considerably smaller than the allowable bending moment of the pile. This is likely that the relative horizontal displacements of the piles to soil below the raft to the depth of 16 m, where the soil was confined by the deep mixing walls, were small.

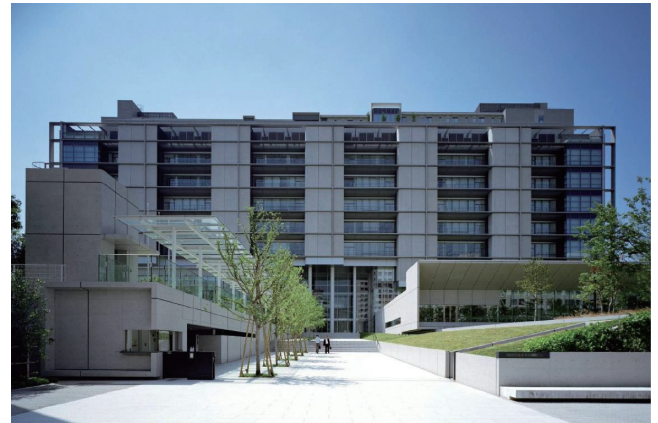
Photo 6 12-story office building in Tokyo

The 12-story office building, shown in Photo 6, is located in Tokyo, 0.3 km southeast from the twelve-story residential building (Yamashita et al. ¹⁵⁾). Figure 19 shows a schematic view of the building and the foundation with a soil profile. The building, 55.7 m in height above the ground surface and measuring 120 m by 100 m in plan, is a steel-framed structure with a base isolation system of laminated rubber bearings. The plan area of this building is about twelve times larger than that of the 12-story residential building. The foundation levels were between depths of 3.6 and 7.2 m.

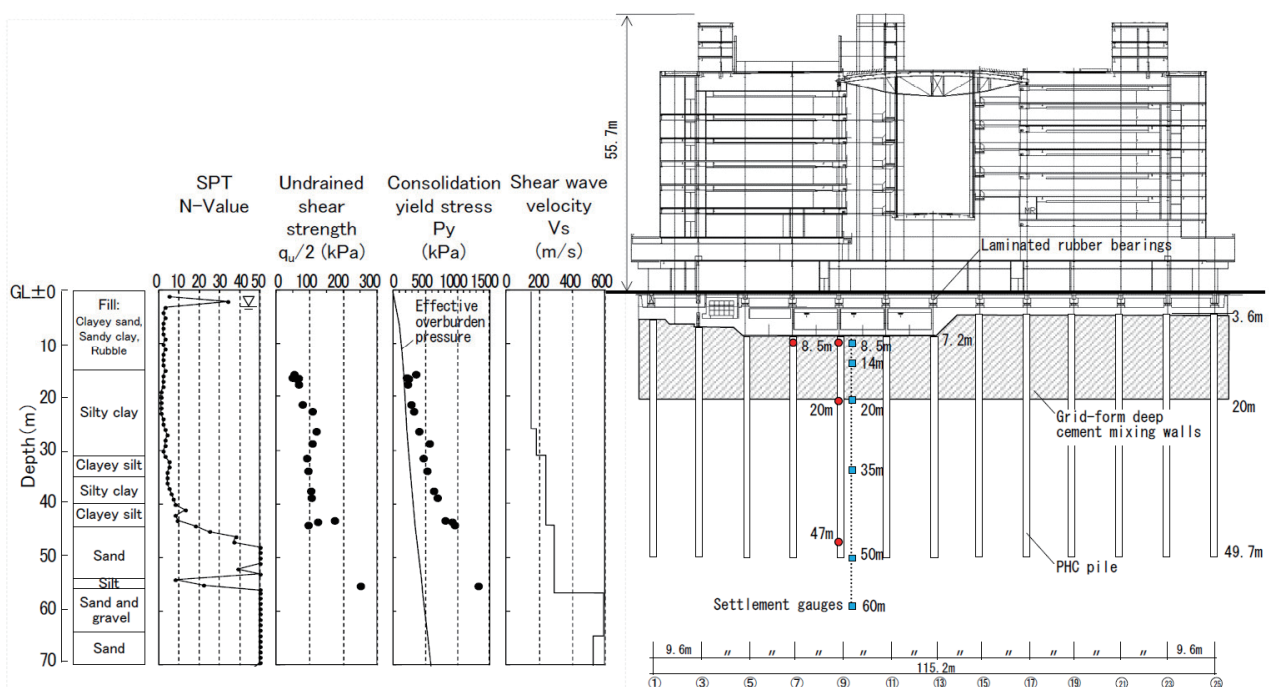
Fig. 19 Schematic view of building and foundation with soil profile

The subsoil consists of an alluvial stratum to a depth of 44 m below the ground surface, underlain by a diluvial very dense sand. The ground water table appears approximately 3 m below the ground surface. The soil profile down to a depth of 15 m is made of fill which consists of loose clayey sand, sandy clay and rubble. Between the depths of 15 to 44 m, there lie very soft to medium silty clay which is slightly overconsolidated with an OCR of 1.3 or higher. The shear wave velocities derived from a P-S logging were 150 m/s at the foundation levels and 290 m/s in the dense sand below the depth of 44 m.

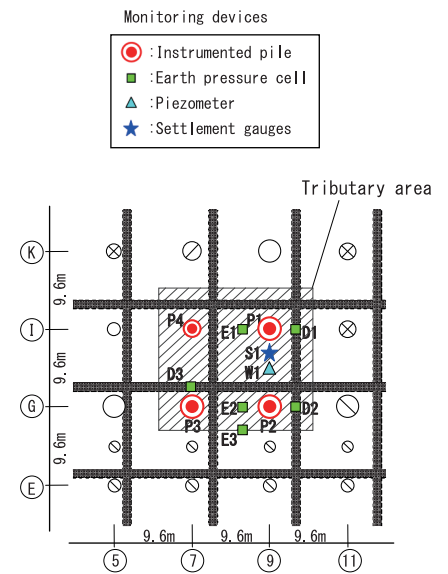
Fig. 21 Locations of monitoring devices

Field measurements were performed on the foundation settlement, the axial loads of the piles and the contact pressure between the raft and the soil, as well as the pore-water pressure beneath the raft, from the beginning of the construction to 21 months after the end of the construction. The locations of the monitoring devices are shown in Figs. 20 and 21. Four piles, P1, P2, P3 and P4, were provided with a couple of LVDT-type strain gauges at depths of 8.5 m (near pile head), 20.0 m and 47.0 m (near pile toe) from the ground surface (Photos 7 and 8). In the tributary area of the instrumented piles, six earth pressure cells and one piezometer were installed beneath the raft at the depth of 7.2 m. Earth pressure cells E1-E3 were installed on the soil and earth pressure cells D1-D3 were installed on the deep mixing walls. The vertical ground displacements below the raft were measured by differential settlement gauges. LVDT-type transducers were installed beneath the raft at depths of 8.5 m, 14.0 m, 20.0 m, 35.0 m and 50.0 m to measure the relative displacements to a reference point at a depth of 60.0 m. The settlements of the foundation were measured at the monitoring points on the raft by an optical level. The measurement of the vertical ground displacements was begun during the foundation construction excavation. The measurement of the axial loads of the piles, the contact pressures and the pore-water pressure beneath the raft was begun just before the casting of the 0.6-m-thick foundation slab.

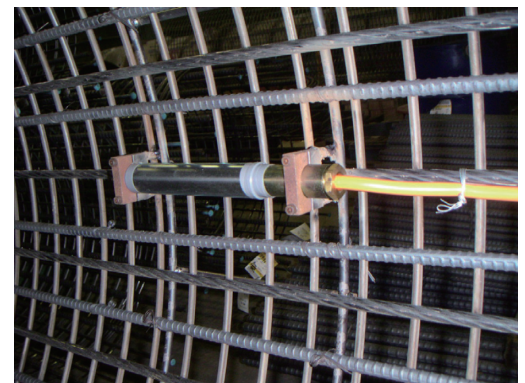
Photo 7 LVDT-type strain gauge

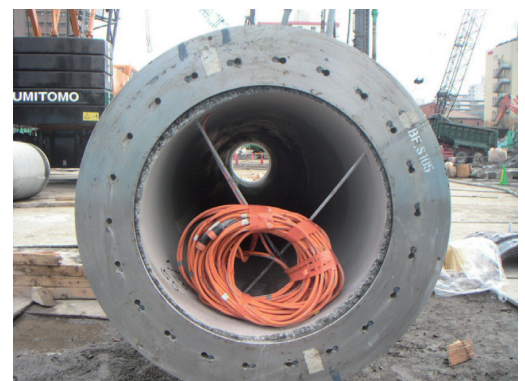
Photo 8 Instrumented PHC pile

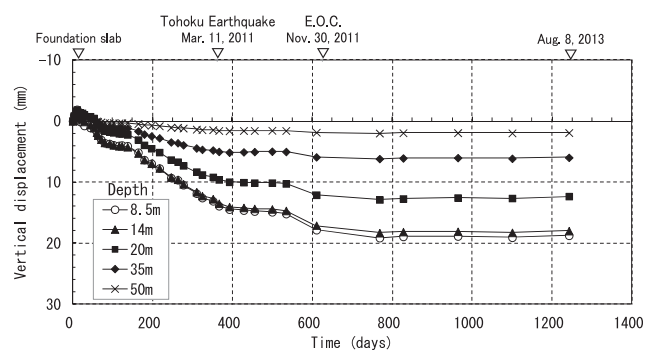
Fig. 22 Measured vertical ground displacements below raft

Figure 22 shows the measured vertical ground displacements below the raft. The measured ground displacement at the depth of 8.5 m after the casting of the foundation slab was approximately equal to the foundation settlement. The foundation settlement increased considerably just before the end of the construction (E.O.C.) due to the water pouring into the underground pits. Thereafter, the foundation settlement became stable and reached 21 mm at the end of the observation (August 8, 2013). Figure 23 shows the settlement profile of the raft measured by the optical level about 1.5 months before the end of the construction. The measured settlements were 12 to 24 mm and the maximum angular rotation of the raft was 1/1400 rad, which satisfied the design requirements.

On March 11, 2011, 9 months before the end of the construction, the 2011 off the Pacific coast of Tohoku Earthquake struck the site of the building. The contact pressure between the raft and the deep mixing walls increased markedly after the earthquake as shown in Fig. 26(a), while the contact pressure between the raft and the soil changed a little as shown in Fig. 26(b). As a result, no significant changes in foundation settlement or load sharing were observed after the earthquake, as shown in Figs. 22 and 28.

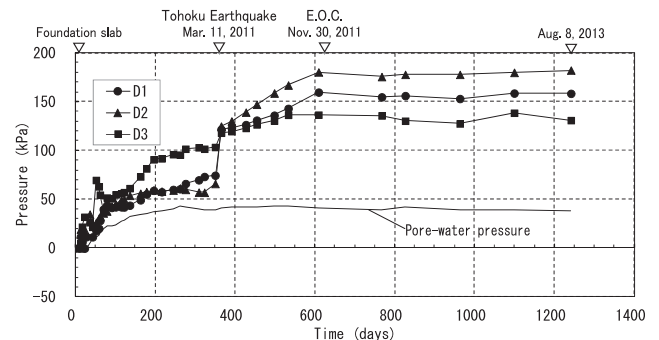
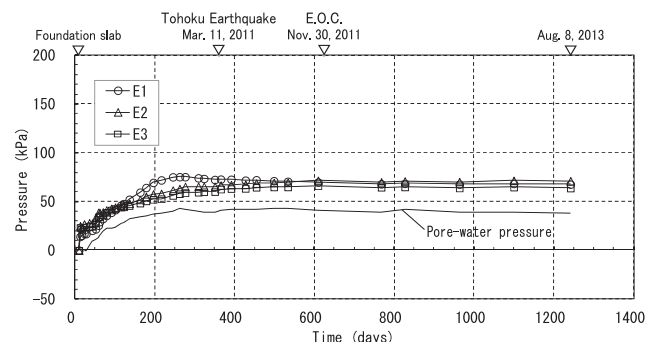
Fig. 26 Measured contact pressures and pore-water pressure beneath raft

pressure between the raft and the soil reached 64-71 kPa. The measured pore-water pressure was quite stable (38-40 kPa) before and after the end of the construction.

(a) Contact pressures between raft and deep mixing walls

(b) Contact pressures between raft and soil

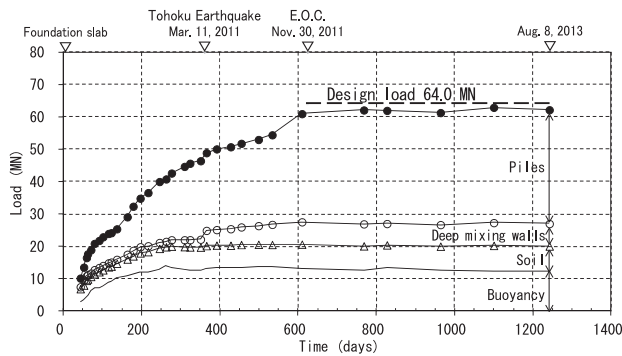
Fig. 27 Time-dependent load sharing between raft and piles in tributary area

Figure 27 shows the time-dependent load sharing among the piles, the soil, the deep mixing walls and the buoyancy in the tributary area of the instrumented piles shown in Fig. 4. The sum of the measured pile-head loads and the raft load in the tributary area varied from 61.3 to 63.0 MN after the end of construction, which was generally consistent with the design load of 64.0 MN. Figure 28 shows the ratios of the load carried by the piles to the effective load and that to the total load in the tributary area versus time. The ratio of the load carried by the piles to the effective load was estimated to be 0.70 just before the end of the construction and increased only slightly to 0.71 at the end of the observation. Meanwhile, the ratio of the effective load carried by the deep mixing walls to the effective load was 0.14 and the ratio of that carried by the intact soil to the effective load was 0.15 at the end of the observation.
